## CONSTRUCTION & MAINTENANCE

### Propeller Strikes And Dialing A Crankshaft

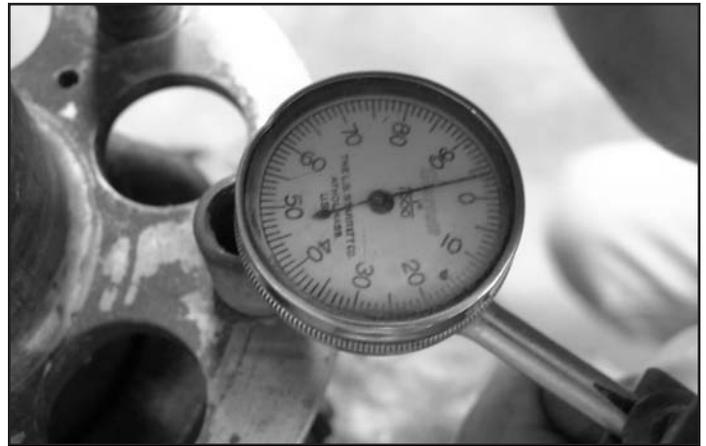
*The greatest 'negative' reading was - .004".*

This particular engine has a seriously bent crankshaft flange. The total reading is .022" (.018 + .004). The Lycoming O-235 Engine Manual states: measure the run-out from the front face of the flange, near the outer edge. If the total flange run-out does not exceed .018", straightening operations are permissible. In the case of the example engine, the run-out exceeds Lycoming's maximum limits making the crank unusable in an aircraft.

**CAUTION:** Any attempt to straighten a bent crankshaft will result in rupture of the nitrided surfaces of the bearing journals – a condition that will eventually cause failure of the crankshaft. Crankshafts that have been straightened or have been reground must be renitrided.

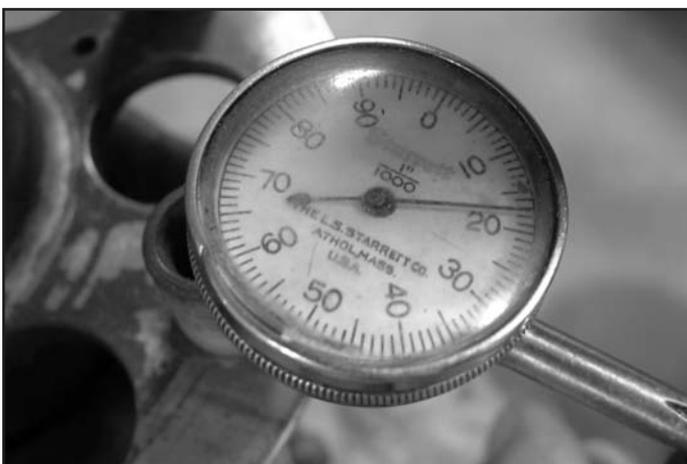
*In the case of this particular engine, the maximum 'plus' reading was +.018"*
