## CONSTRUCTION & MAINTENANCE

### Propeller Strikes And Dialing A Crankshaft

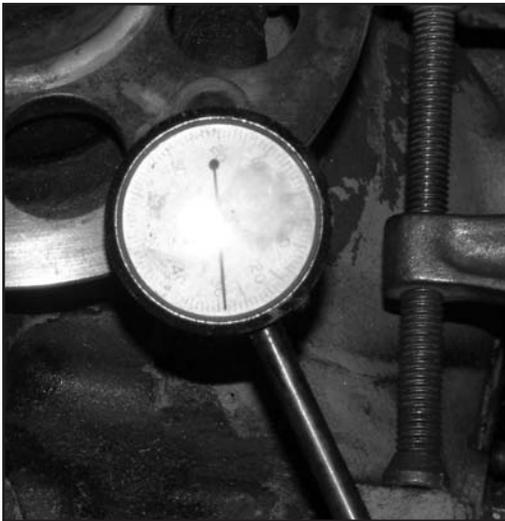
*After adjusting the sensitive probe, "Zero" out the dial. Note how the flange surface has been cleaned of all dirt and foreign matter.*

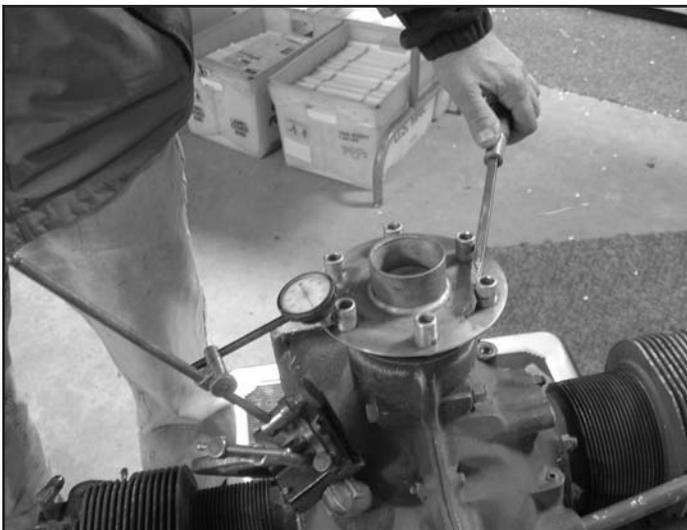
*With the dial "zeroed" and the probe in position, slowly rotate the crankshaft using a larger screwdriver. As you rotate the crankshaft make careful note of the dial readings, noting the maximum 'plus' and 'negative' readings.*
